**DRIVER OBEDIENCE  
TO  
STOP AND SLOW SIGNS**

**MARCH, 1956  
No. 8**

**Joint  
Highway  
Research  
Project**

*by*  
**William T.  
Jackman**

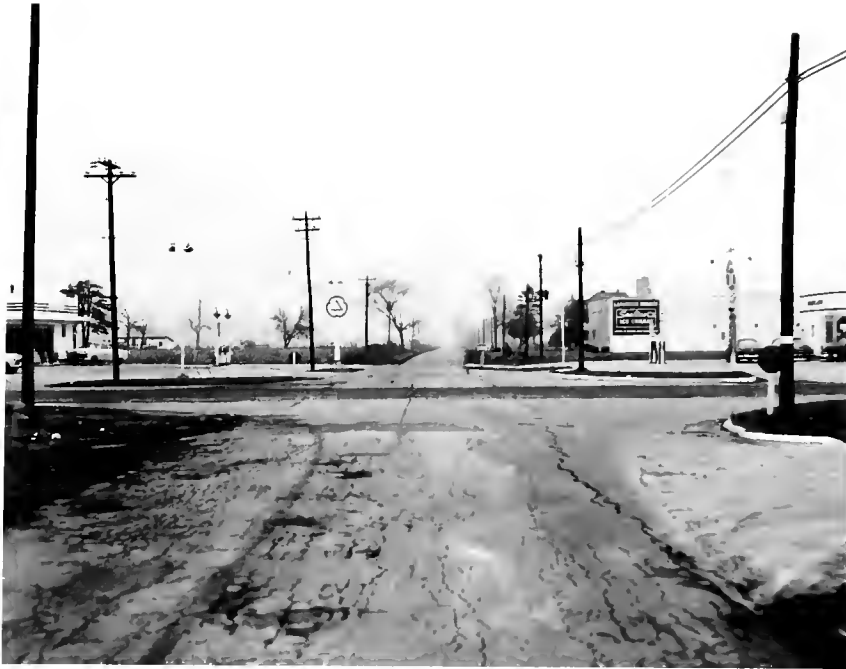
Plate I Location I - 100 feet from existing stop sign

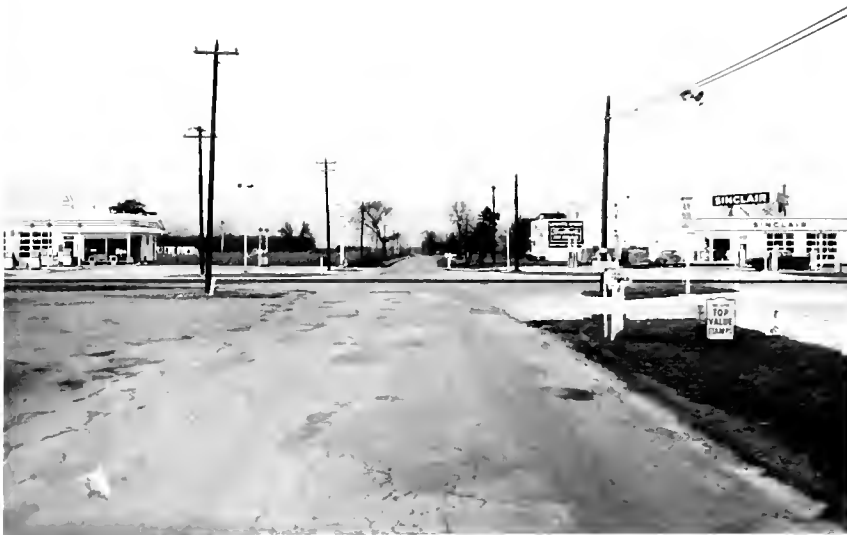
Plate II Location I - 200 feet from existing stop sign

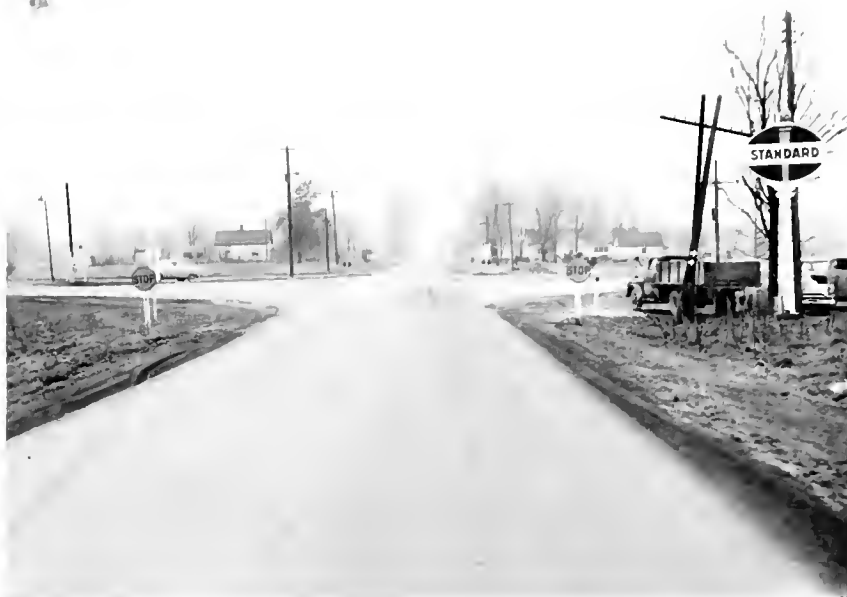
Plate III Location II - 100 feet from existing stop sign

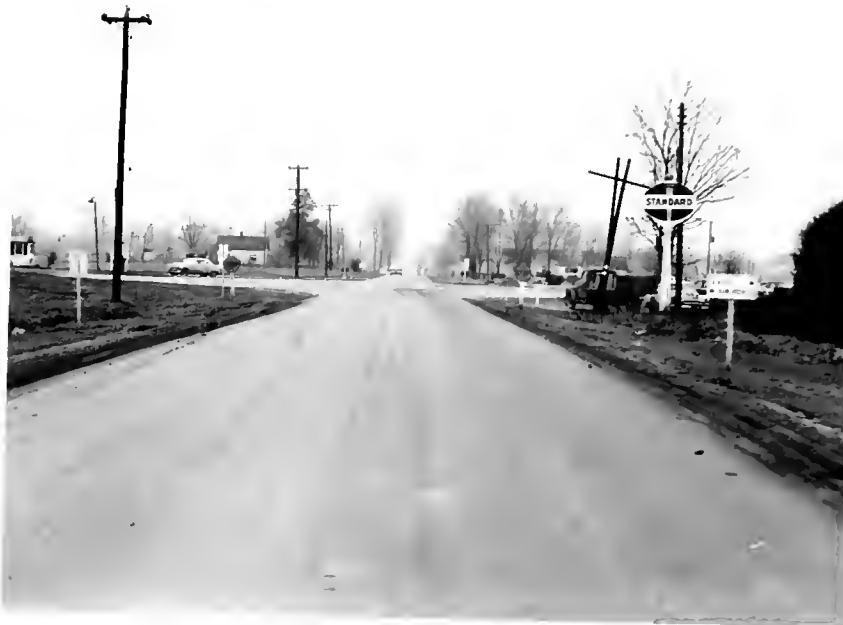
Plate IV - Location II - 200 feet from existing stop sign

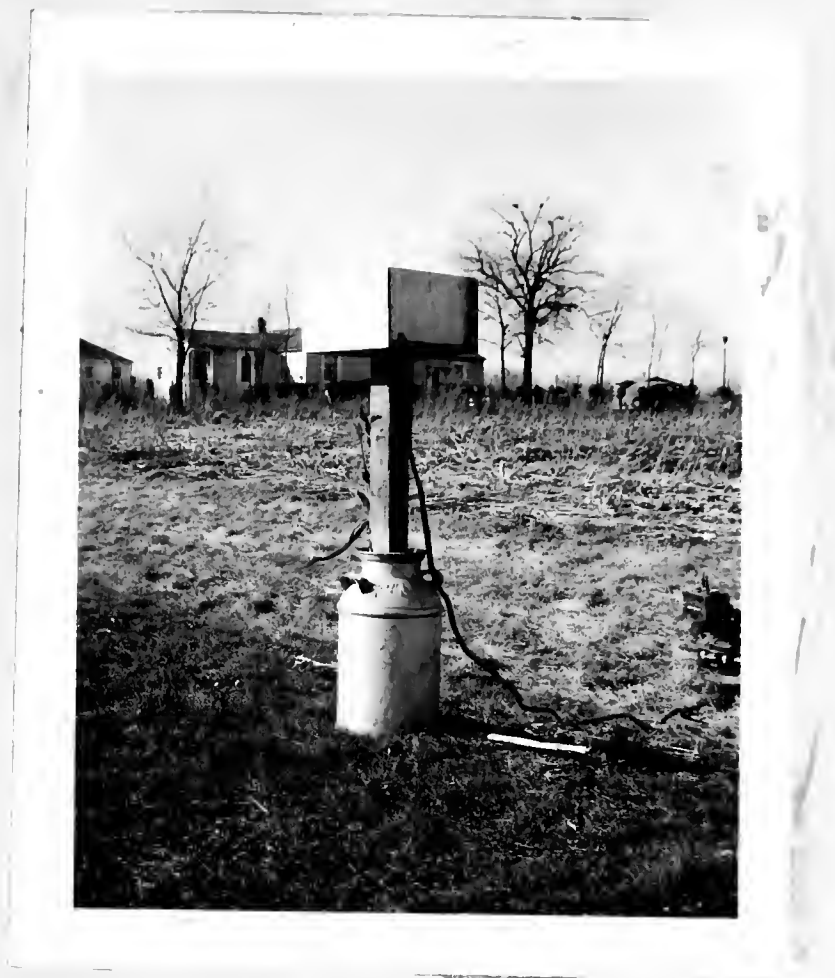
Plate IX Location I - Radar unit in 'milk can' mount

The radar meter mount (See Figure 3 and Plate IX) was designed and constructed by the author. It consisted of a 10 gallon milk can, half filled with concrete to act as the base. Before pouring the concrete a 4" x 4" wooden post, greased and wrapped in heavy paper, was placed in the milk can. After the concrete hardened this post was removed for easier handling. The post was of such a length so as to bring the top of it to a distance of 4 feet above the ground. A box, constructed of 1/4 inch plywood, measuring 15 inches in length, 15 inches in width, and 8 inches in height was mounted on the top of the post by means of a heavy steel bracket. The box, made to simulate a rural mailbox, was left open at the front to allow interference free operation of the radar unit and was equipped with a removable back for easier handling. A small opening was provided in the back to allow for the passage of the electrical cable of the radar unit.
